# Global Property Inspections

9375 Burt Street

A property condition assessment was performed by Global Property Inspections on the Joe Turnkey office building property, located at 9375 Burt Street, Anywhere, CANADA. The Walk Through Survey was conducted on August 23, 2006, at the time of the walk through four of the five tenant finish spaces were occupied. The subject property is an irregular shaped lot that is approximately 1.23 acres or 53,699 square feet in size with an office building that is approximately 25,650 square feet in size. The lot and building were not measured in the field, the information for the approximate size of the lot and building was gathered from the local County Assessors office. The property is located East of North 94<sup>th</sup> Street and South of Burt Street in the central part of Anywhere CANADA. The legal description of the property is Embassy Tower Lot 4 Bock 0; the property is zoned for commercial use.

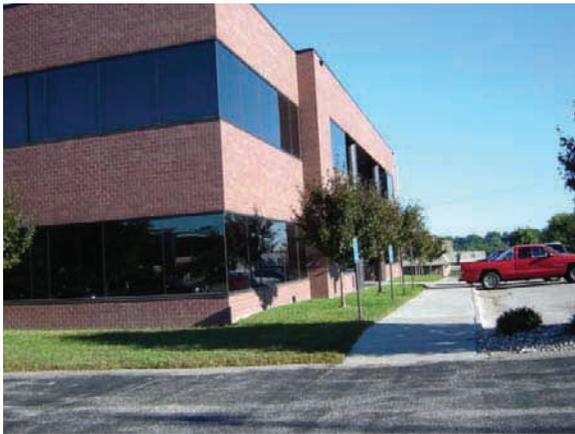
Grade and landscaping

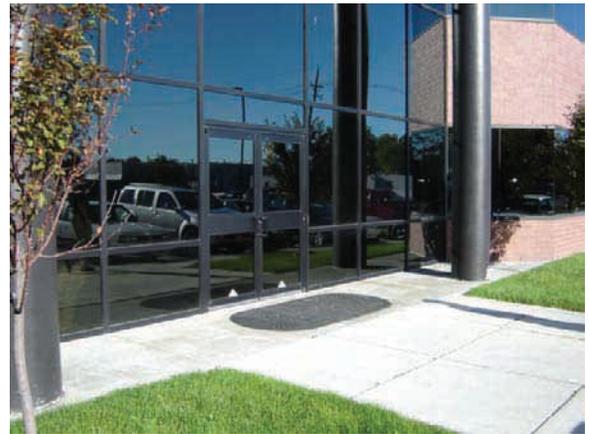
Front Entry Egress

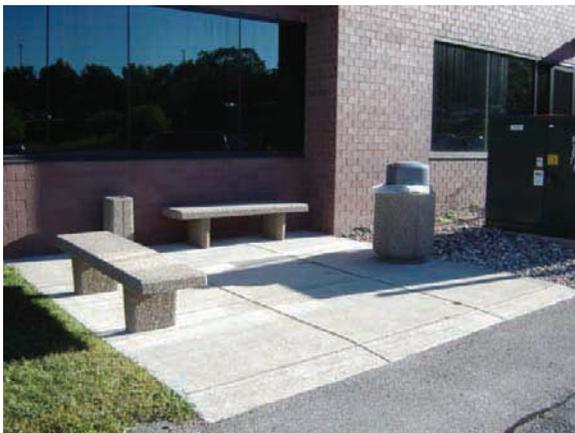
Patio/Flatwork

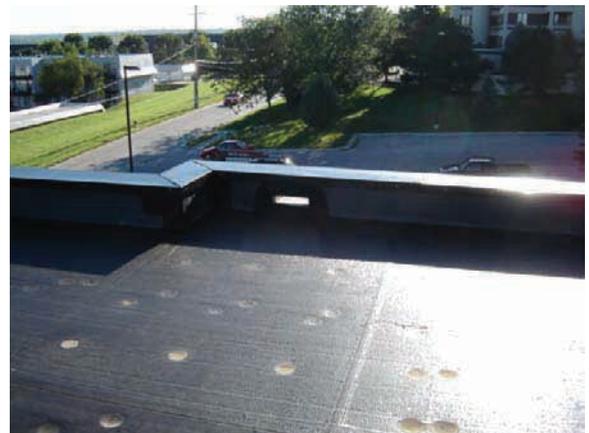
Parapet wall and Scuppers
