1555848 ALBERTA LTD. DBA
Global Property Inspections

Sample Report Included are examples of defects that may be found in homes, , , ,

Inspection Date : 24/02/2013
Inspector: Tim Forest
Inspector Phone: (403) 588-8396

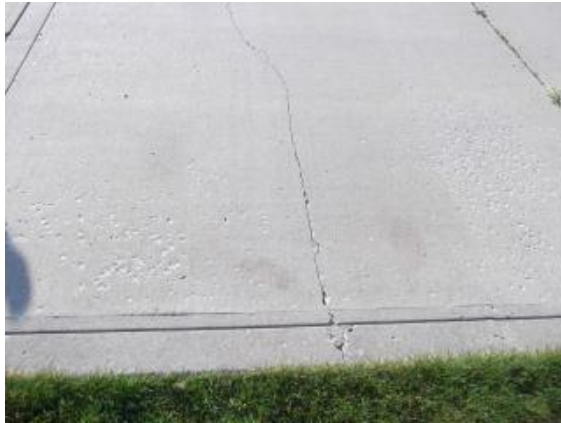
Driveway:

Comments : General deterioration and cracking noted; recommend filling cracks with driveway caulk/sealant to prevent further deterioration.

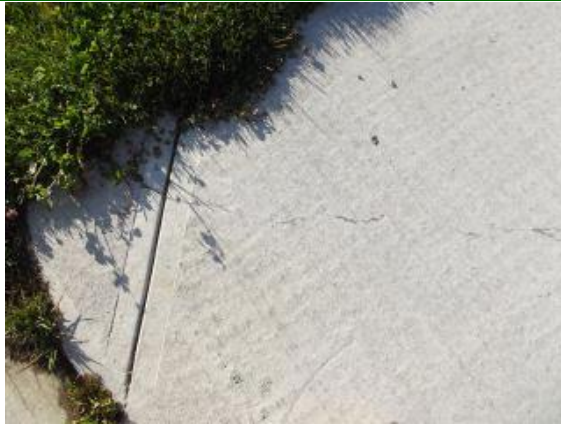
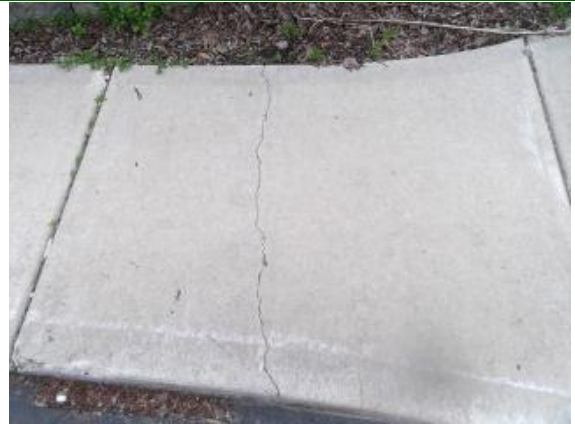
Walks / Steps:

Comments : Minor cracks noted, most likely created in the curing process of the concrete.

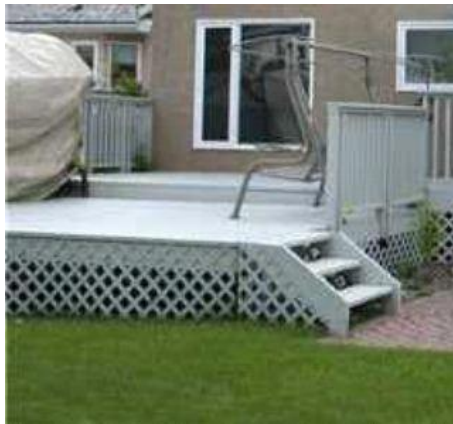
Decks / Balcony:

Deck height is more than 24 inches above grade; recommend installation of a railing as this is a safety issue.

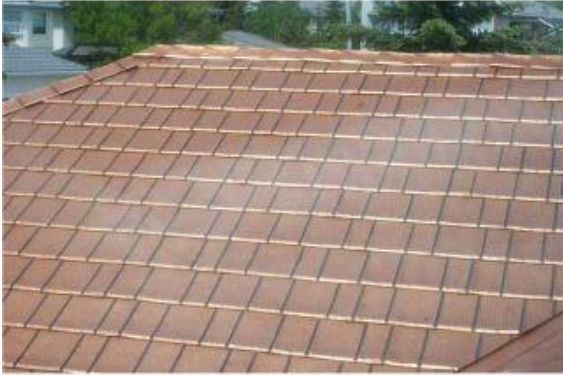
Roofing:

Comments : Leaks not always detectable.

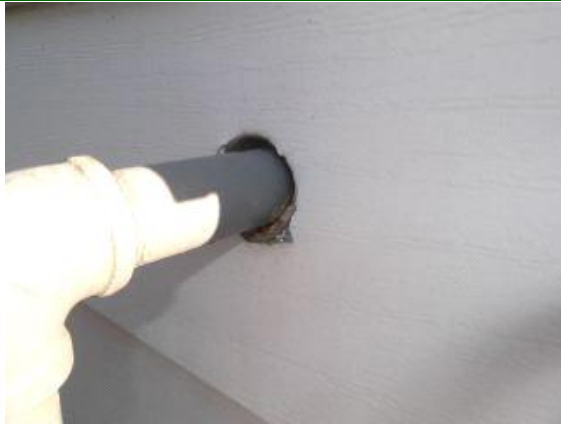
Exterior Surface:

Comments : Utility lines noted as missing caulk/seal where entering house; recommend caulk/seal to prevent water/moisture intrusion.

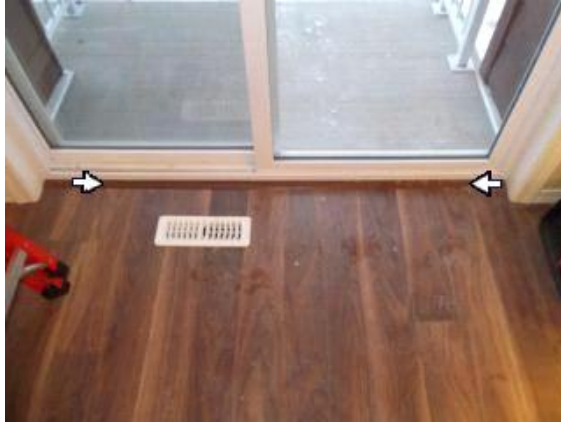
Exterior Doors:

Comments : Sealing and caulking required on inside of doors where threshold meets flooring to prevent water damage to the sub-flooring. It is standard home maintenance to insure a good seal and should be replaced when necessary.

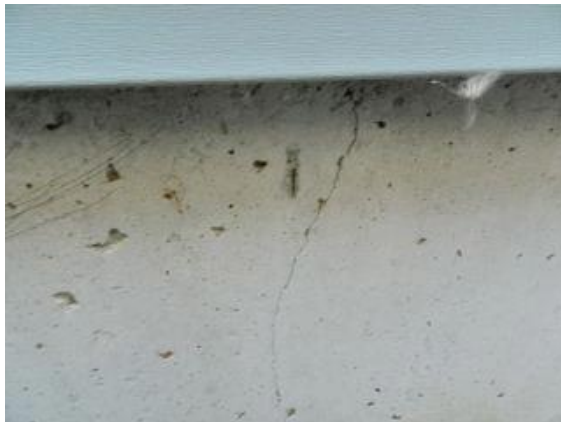
Foundation:

Comments : I did not identify any foundation problems from the exterior. Minor vertical crack noted, most likely created in the curing process of the concrete walls. Due to landscaping and design, visibility of the foundation is limited.

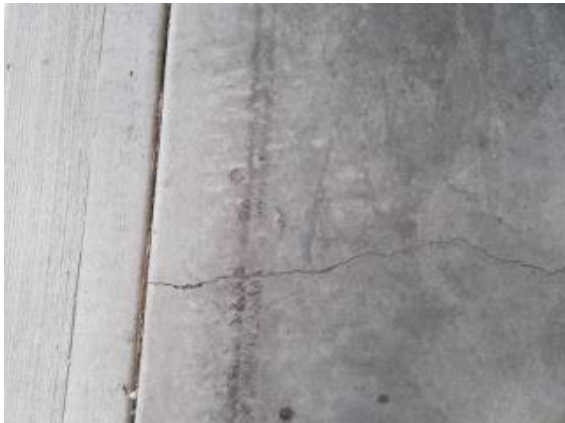
Garage:

Comments : Noted small cracks most likely created in the curing process of the slab.

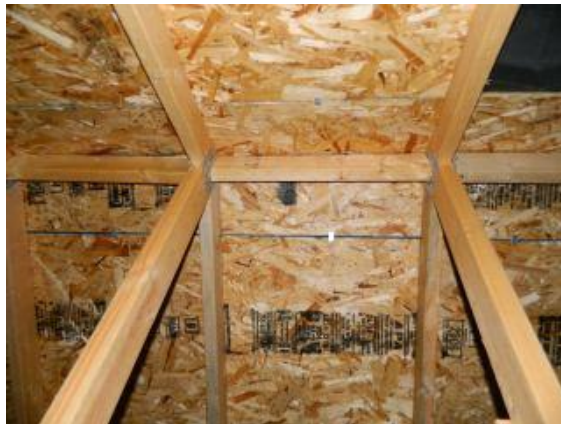
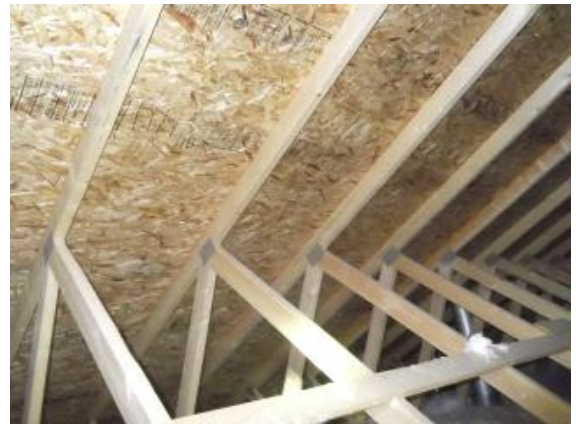
Framing/Sheathing:

Comments : **Leaks not always detectable.**
 My inspection of the attic was limited to a visual inspection from the access door. I didn't identify any problems with the framing and sheathing that I could see. Broken, cracked or missing bottom chords of trusses are not visible due to insulation cover and the possibility of damaging the ceiling below by attempting to walk inside the attic is too high. The bottom side of the roof structure has drywall attached (finished ceilings) that conceal the bottom of the roof; bottom side of roof was not visible for inspection.

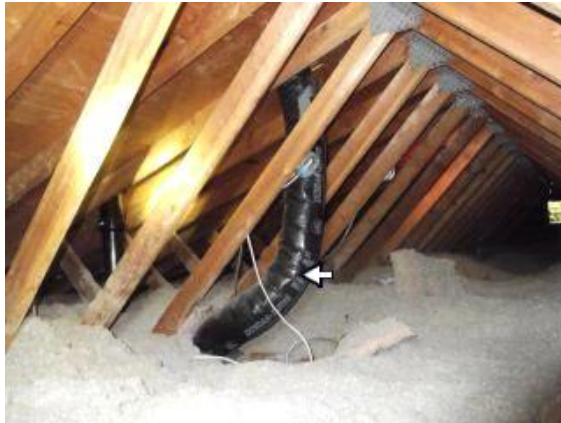
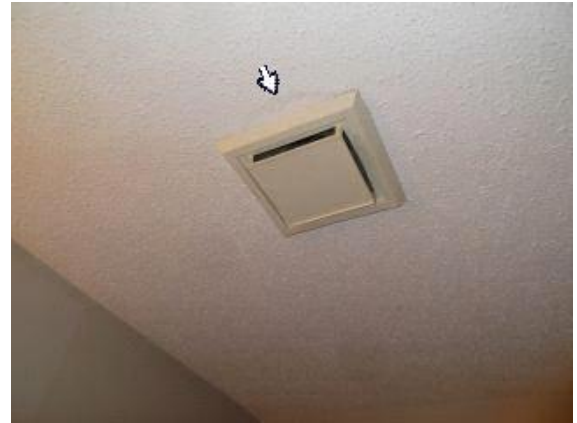
Ventilation:

Comments : Venting for exhaust fan noted as having no drip loop, water stains noted on ceiling around exhaust vent in ensuite; recommend installation of vent with a drip loop, to prevent condensation build up and possible water/moisture damage to surrounding areas. This should only be done by a qualified, insured contractor.

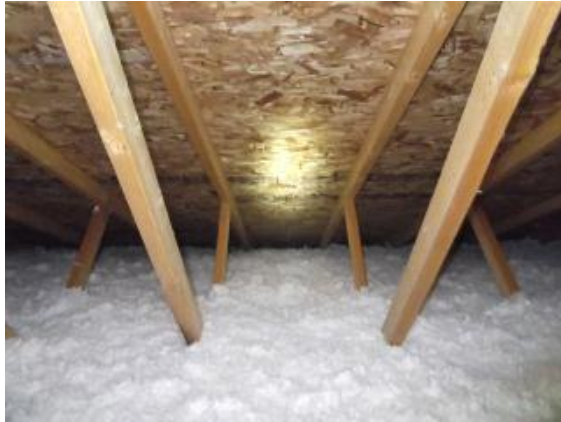
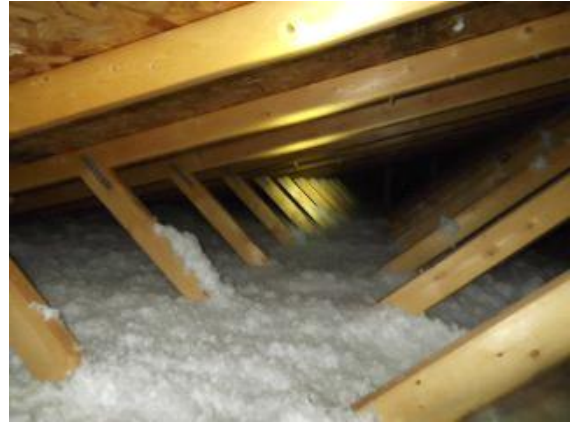
Insulation:

Comments : Loose fill insulation is well distributed through out attic where visible from the access door. No moisture was evident on insulation where visible from the access door. Noted approximately 12 inches = approx. R40

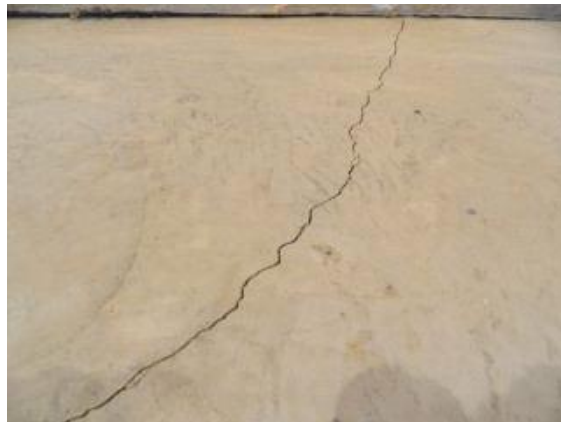
Floor/Slab:

Comments : Concrete slab not visible due to design, finish, and occupants personal items with the exception of the mechanical room. Noted small crack that was most likely created in the curing process of the slab. Recommend filling cracks with a non-shrinking sealant to reduce possibility of deterioration.

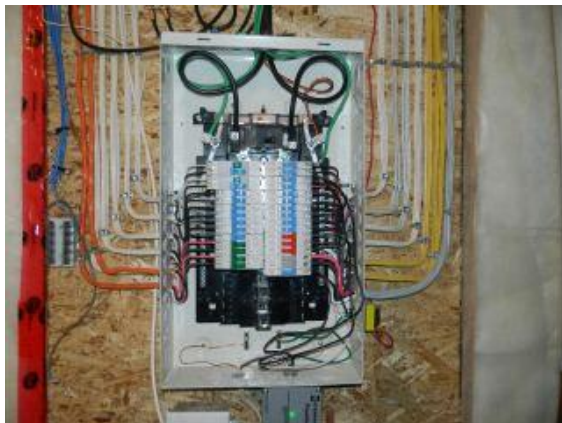
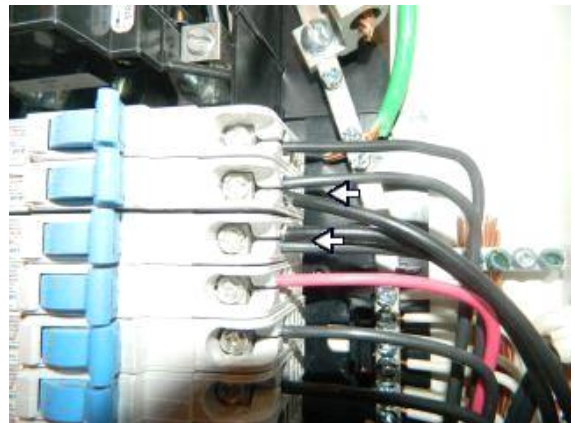
Electrical:

Comments : ***Smoke Detectors / GFCI's checked with test button only. Monthly Test Recommended.**
 Smoke detectors should be tested on day of takeover. Recommend installation of smoke detectors if not present and replacement of detectors if they appear to be more than 5 years old.
 Noted two double-tapped breakers; recommend repair by a qualified electrician.

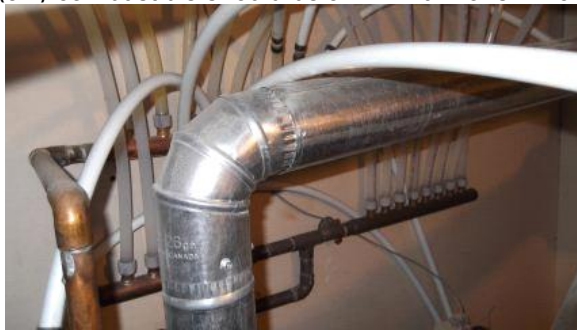
Plumbing:

Plastic water line installed too close to flue; recommend repairs to be done by a qualified plumber (any combustible should be a minimum of six inches away from flue).

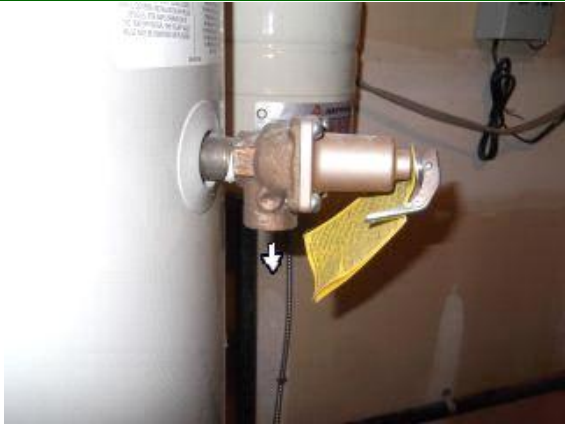
Water Heater:

No T/PR valve extension noted. T/P Relief valve tube must exit within 6 inches of floor.
 Recommend extension tube be installed as this is a safety issue.

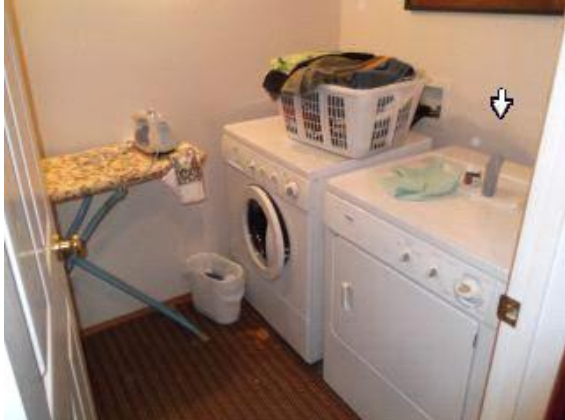
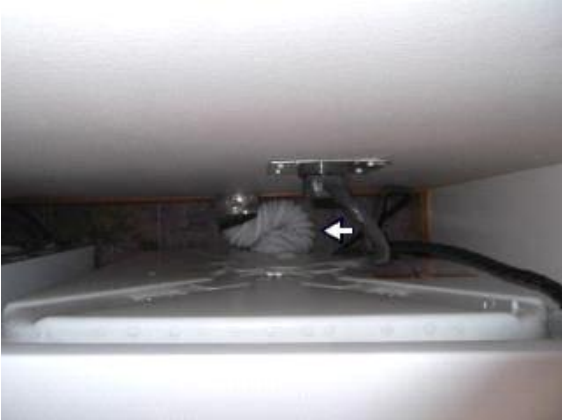
Laundry Facilities:

Recommend changing dryer vent to an approved discharge vent as the vinyl vent is not approved for this purpose and can be a fire hazard.

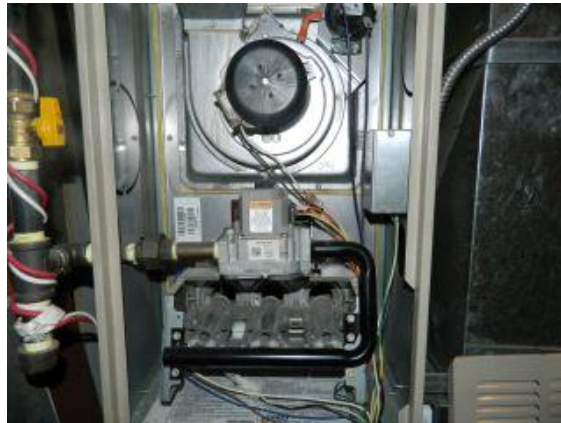
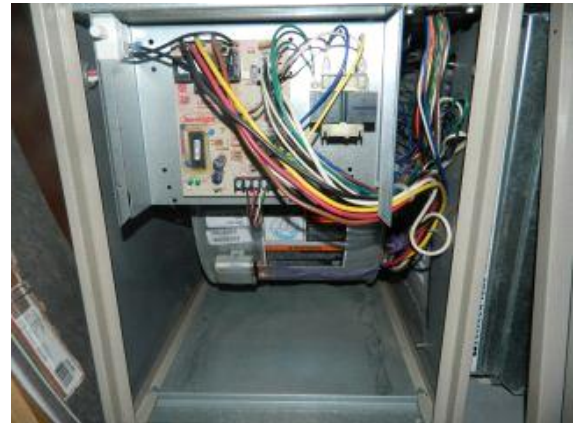
Heating:

Comments : **Heat Exchanger - Unable to detect cracks/holes without dismantling unit.**

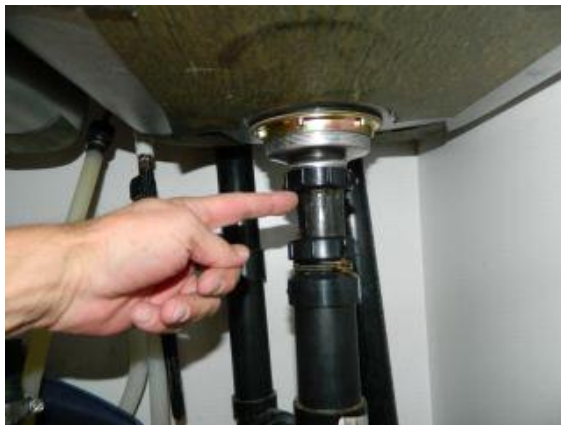
Kitchen/Dining:

Drain pipe leaks under kitchen sink. Recommend repair by a qualified plumber. No GFCI protection noted on electrical outlet near sink; recommend installation of GFCI protected outlets in this wet zone to be done by a qualified, licensed electrician.

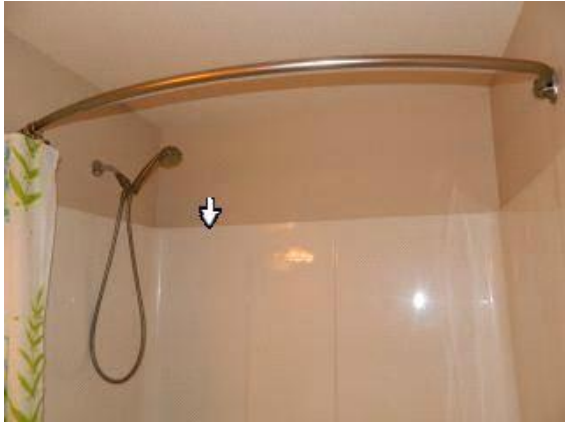
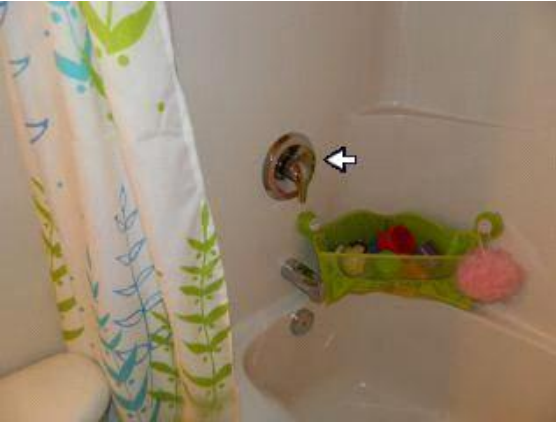
Bathroom Main 4 pc:

Caulking missing around tub fixture, enclosure at tub needs sealing. Recommend caulk/seal to prevent water intrusion behind tub/shower enclosure.

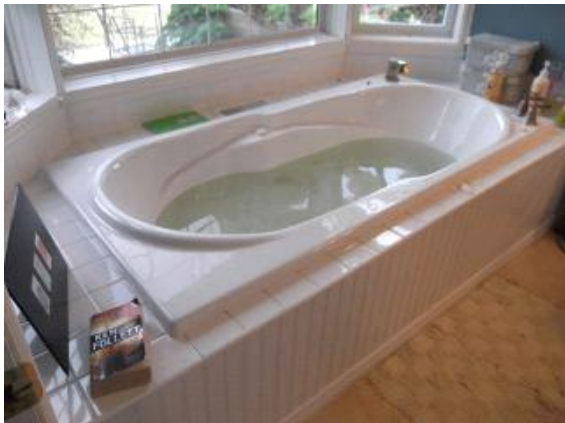
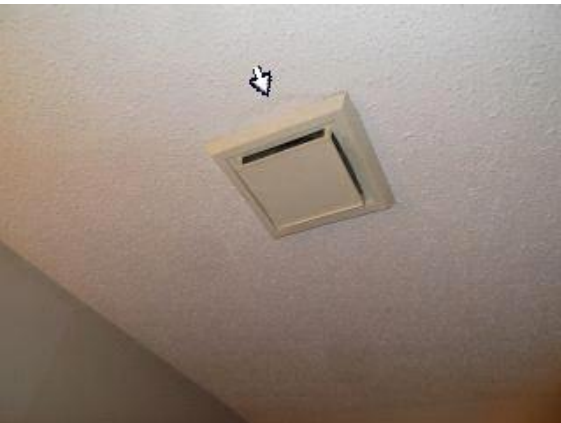
Bathroom Ensuite 4 pc:

Comments : GFCI protection of jet tub could not be verified as it was not visible at the time of inspection; recommend proof of GFCI protection to be verified prior to using tub as this is a safety issue.
